THE SEISMIC BEHAVIOUR OF EXISTING HOLLOWCORE SEATING CONNECTIONS PRE AND POST RETROFIT

A Thesis
submitted in partial fulfilment
of the requirements for the Degree
of
Master of Engineering
at the
University of Canterbury
by
James Jensen

University of Canterbury
Christchurch, New Zealand
2006

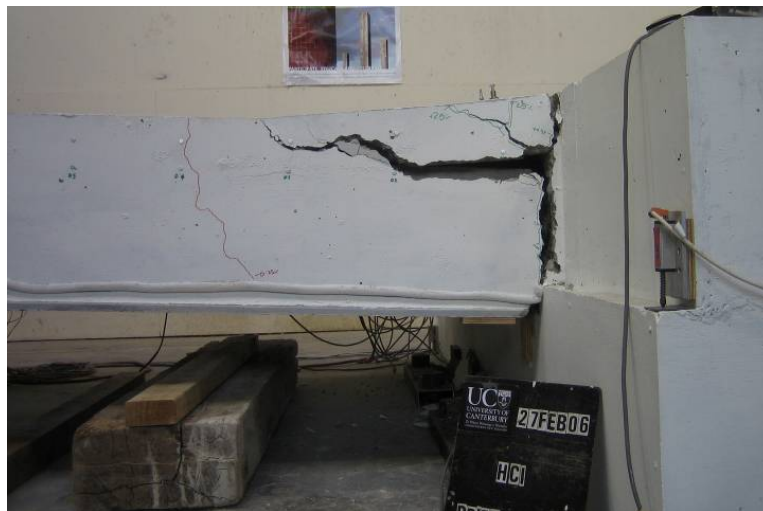
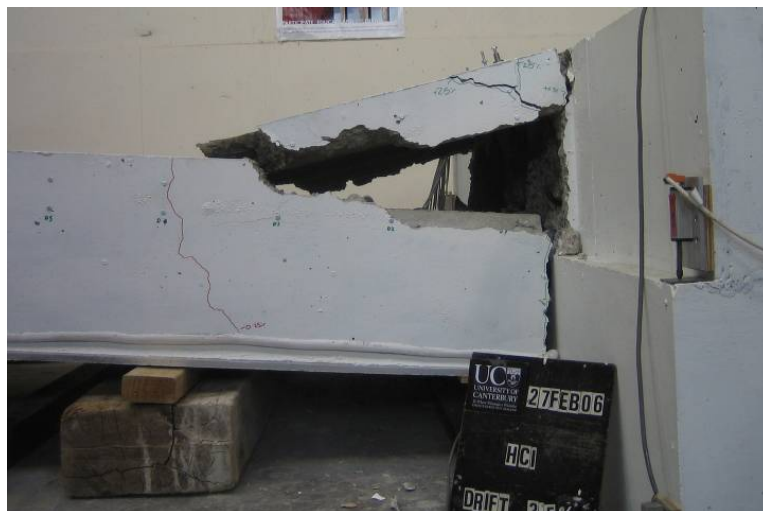
Figure 3-3 Failure sequence of HC1 control specimen during 3.5% drift cycle

At a drift level of approximately +3.1%, and an elongation of approximately 25mm, loss of seating occurred and the unit lost support and dropped off the cracked failure plane. When the unit fell, the topping delaminated from the upper surface of the unit and ruptured at the termination of the starter bars. This is illustrated in Figure 3-3 which shows the progressive dropping of the unit and final collapse and delamination of the topping during the +3.5% drift cycle.

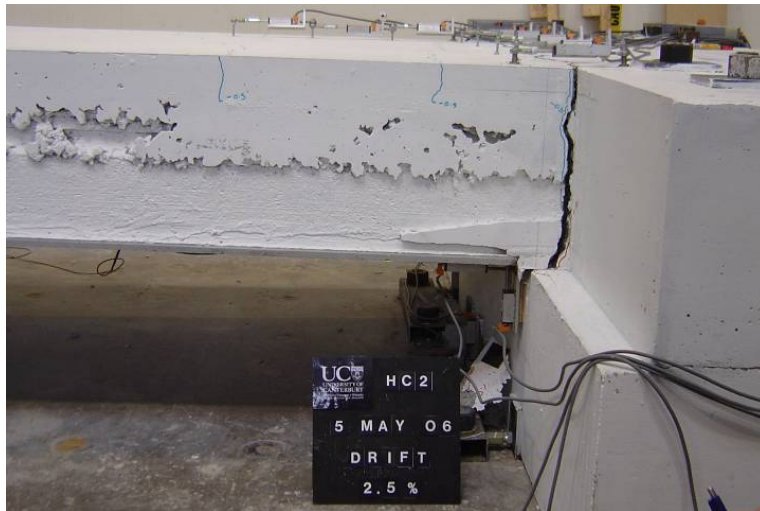
Figure 3-10 Final behaviour sequence of HC2 Control Specimen

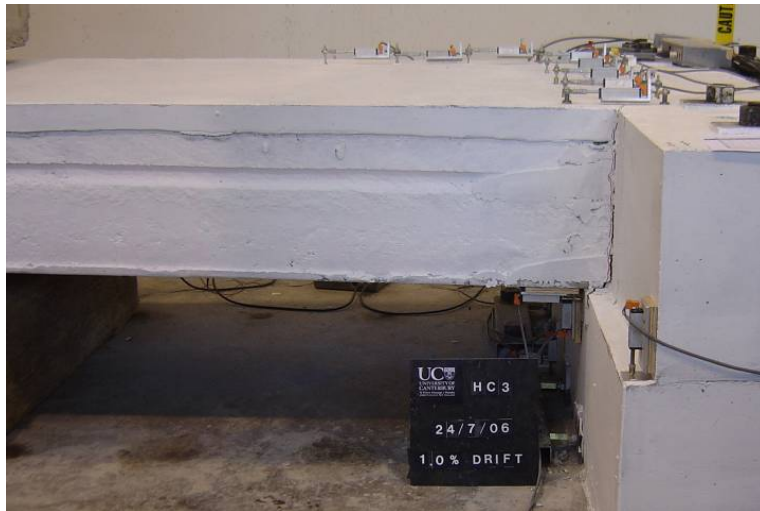
Figure 3-19 Failure sequence of HC3 Control Specimen

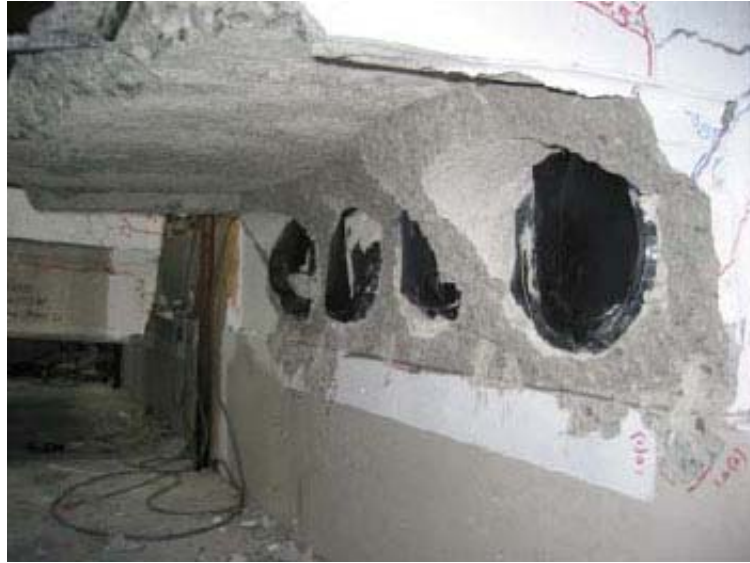
a) Photo of flexure shear failure mechanism from Bull and Matthews (2003)

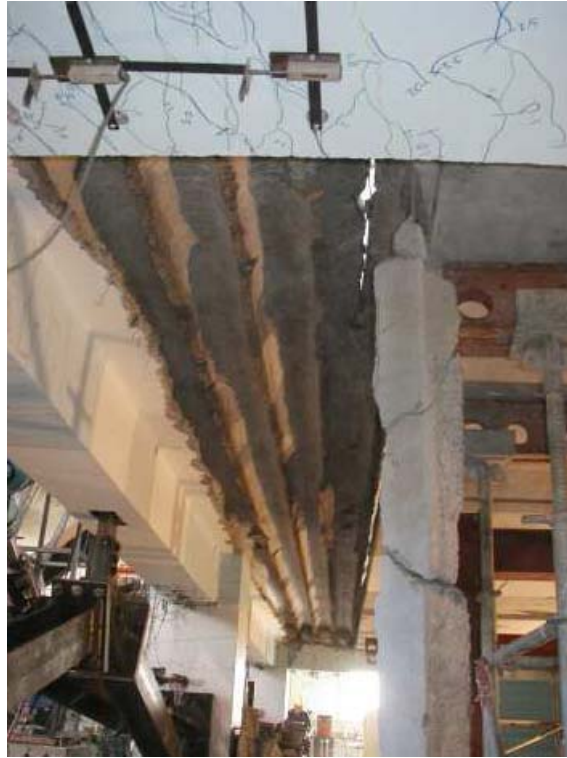
Figure 4-7 Web splitting of hollowcore unit adjacent to longitudinal perimeter connection observed by Matthews (2004)

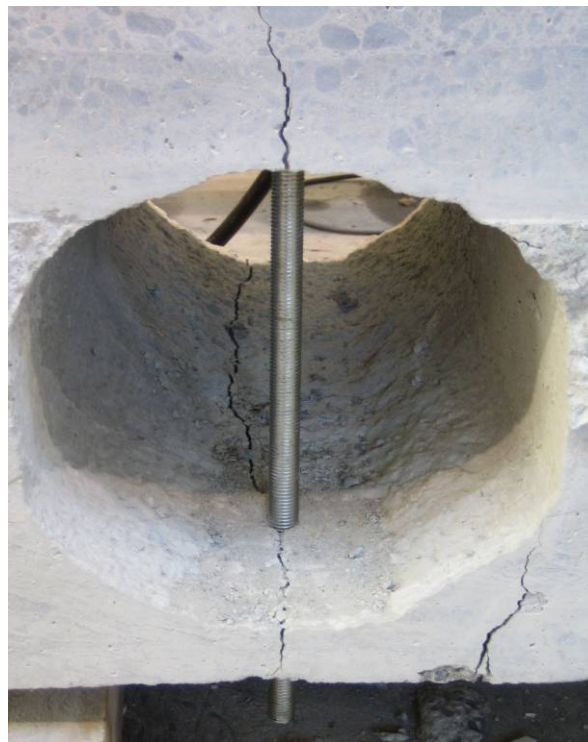
Figure 5-12 Typical longitudinal splitting failure for pull out tests 1-4

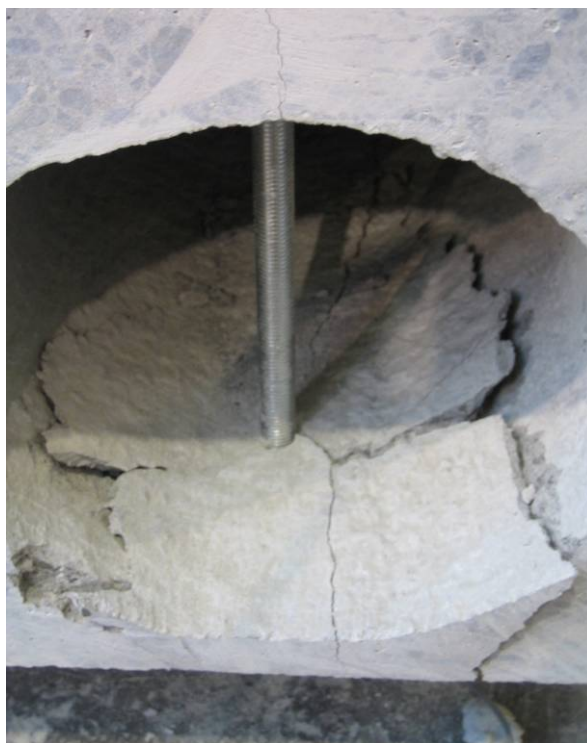
Figure 5-14 Cone pull out in soffit of unit

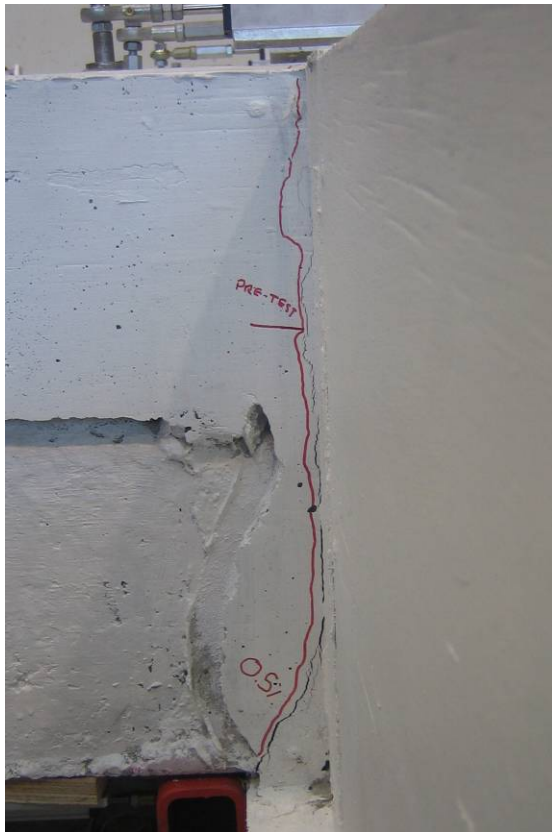
a) Initial rupture of the interface between the hollowcore unit and seating beam at +0.5% drift

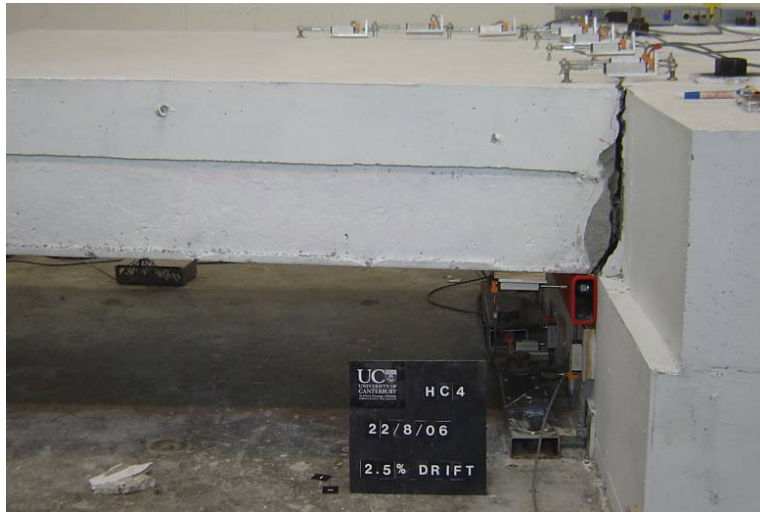
Figure 6-6 Peak drift sequence of HC4 (+2.5%, -2.0%, +3.5%)
